## Minerals Inspection Report

Mine Name: Blind Stream 5-11 Honeycomb	Permit Number: S/013/0004	Mine Status: Active
Operator Name: Floyd Anderson - Shamrock	Inspection Date: 06/25/2013	Permit Fees: Paid
Inspector(s): L. Heppler	Inspection Time: PM	Bond Amount: \$25,300
Attendee(s): Dave Herron - USFS, Tom Hycroft and others	Weather: Cool, Dry	Bond Escalation: 12/22/2014
Inspection Purpose: Routine annual inspection		Prior Inspection: 09/28/2010

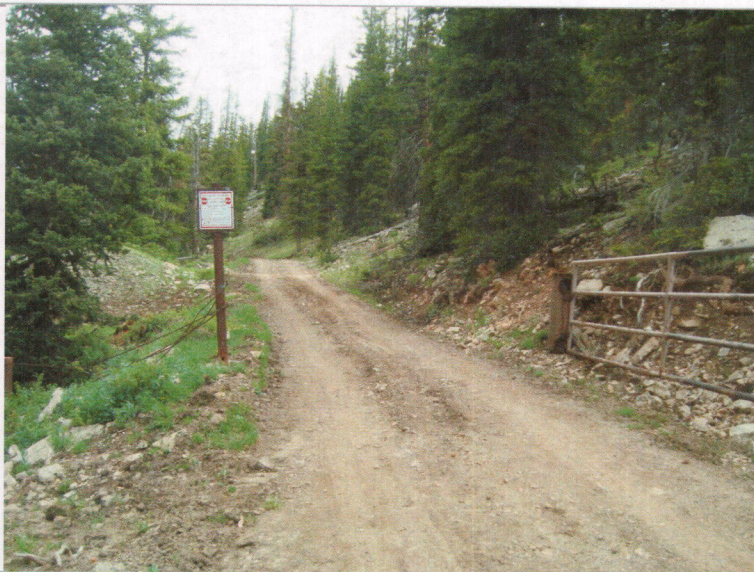
2. <i>Public Safety (shafts, adits, trash, signs, highwalls)</i>	<input checked="" type="checkbox"/>	<input type="checkbox"/>
There is a locked gate at the entrance of the road, there are no underground workings, but there is a highwall.

Gate for access to mine site

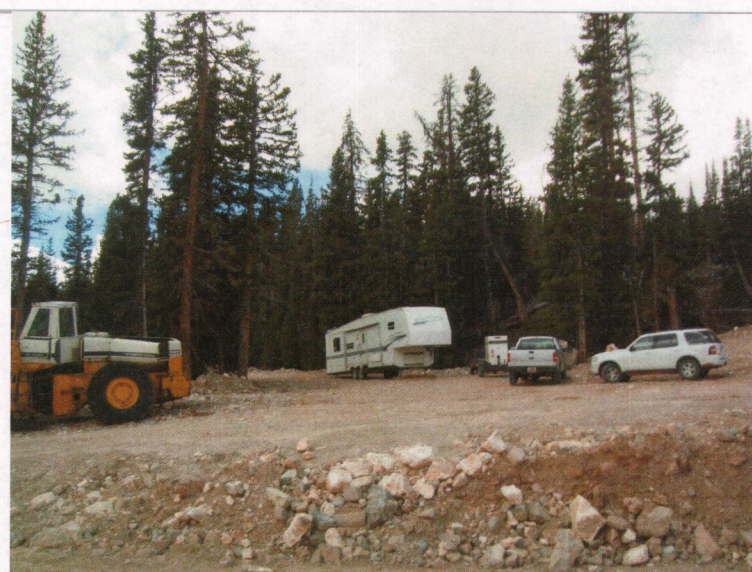
New laydown yard

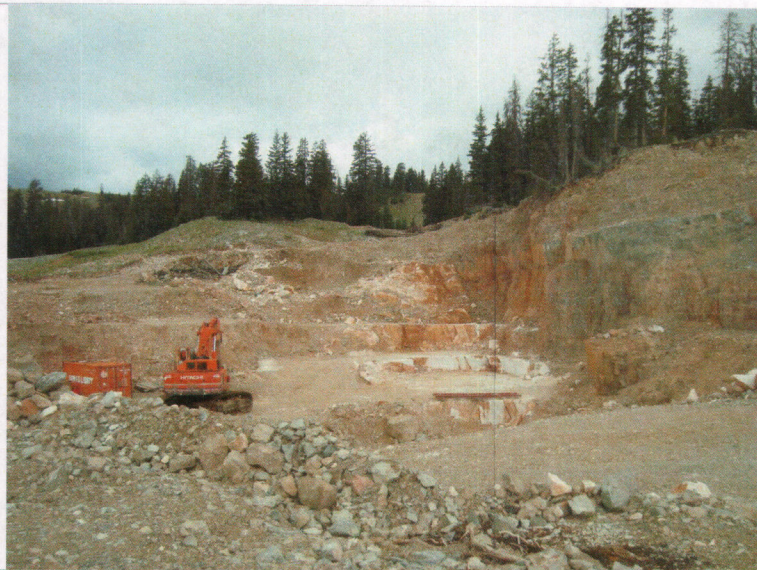
Overview - Mine highwall

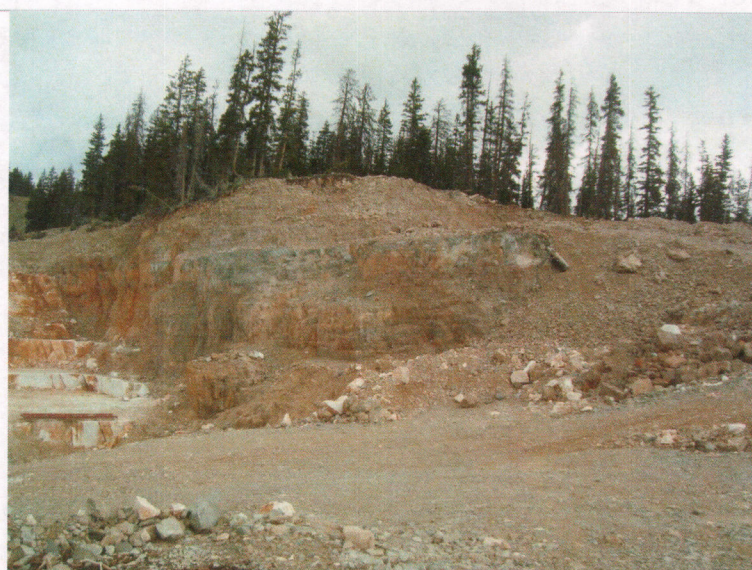
Overview - Mine highwall
